**Pantanal / Taquari project**

River Survey

Report

November, 2004

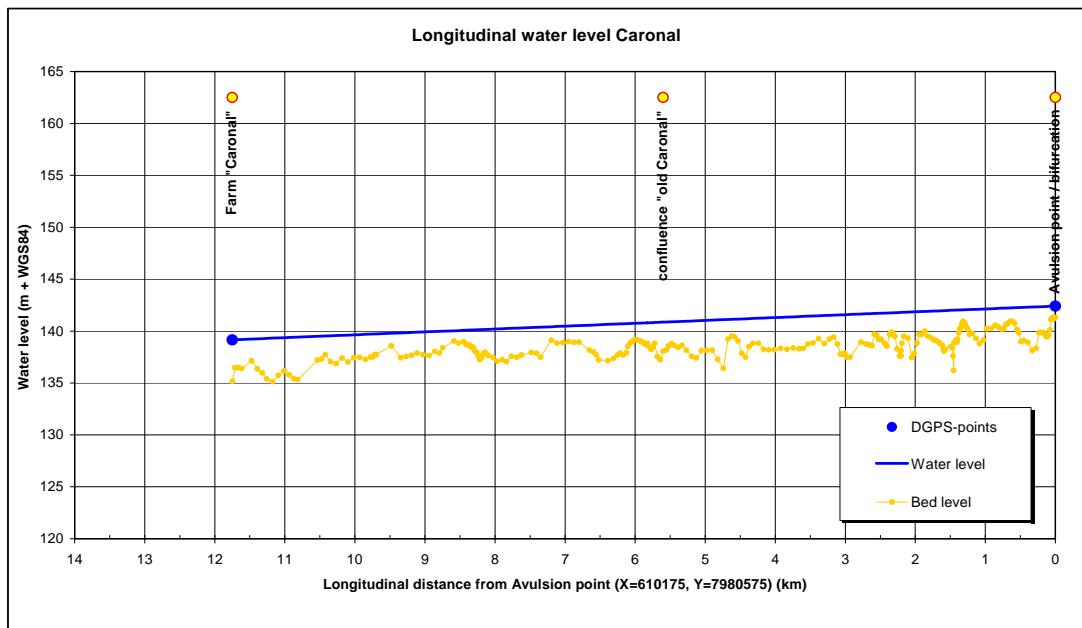
Figure 2-4 Longitudinal profile of the water level and the bed level along the thalweg in the New Caronal (March 30<sup>th</sup> to April 4<sup>th</sup>)

- The slope in water level between Coxim and Ze da Costa is very constant.
- The slope in water level in the upper part of the New Caronal is slightly steeper than the slope of the lower Taquari.

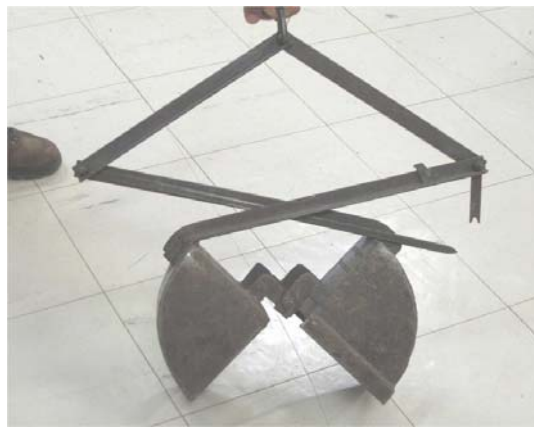
Along the river stretch 17 samples of the river bed material have been obtained, using a Van Veen grabber of approximately 5 litre (see Figure 3-1).

Figure 3-1 Van Veen grabber used for taking the grab samples during the River Survey

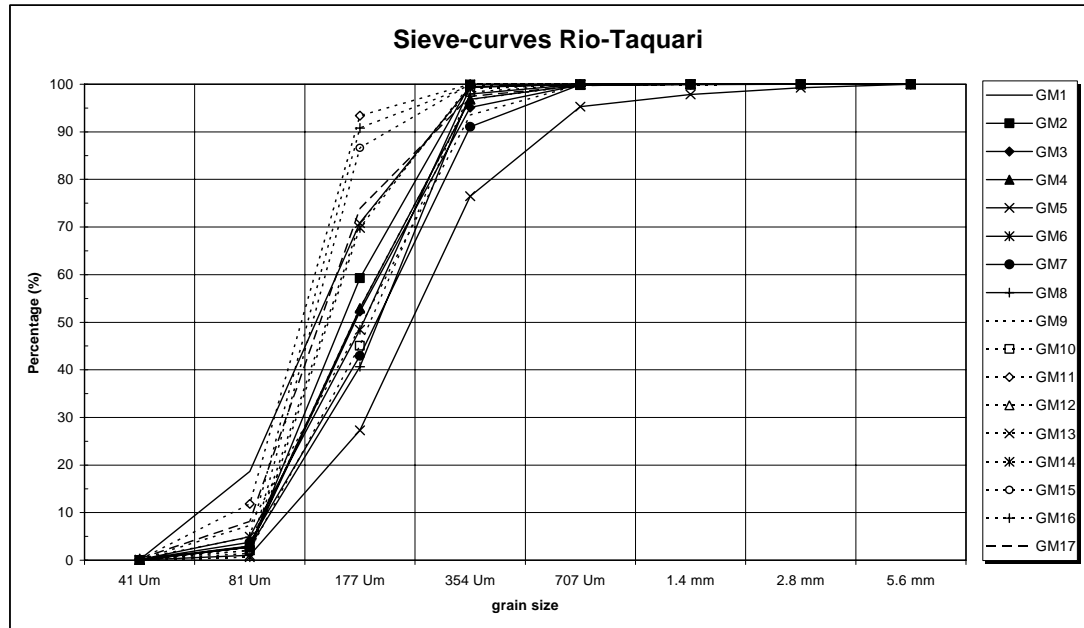
The sediment samples were sieved in the laboratory of Embrapa. From this analysis accumulated sieve curves have been developed, which are presented in Figure 3-2. The actual sieve diameter of the particles was determined as follows: if a particle falls through sieve  $D_A$  and remains on the next sieve  $D_B$  then the actual sieve diameter  $D = (D_A \cdot D_B)^{1/2}$ .

Figure 3-2 Accumulated sieve curves of the river bed samples

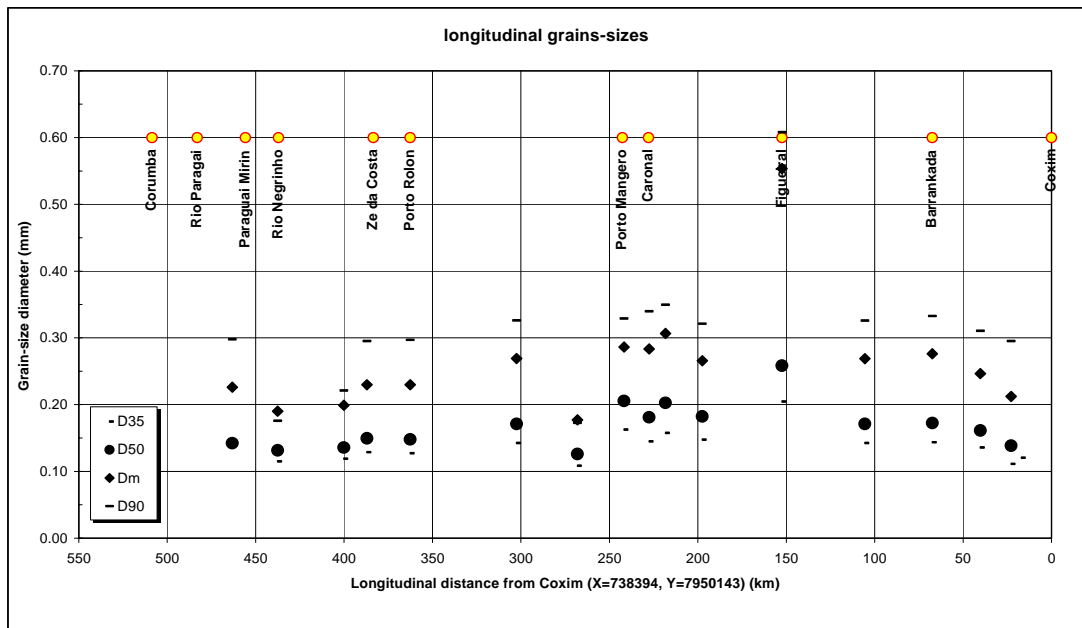
The grain sizes do not vary strongly in downstream direction, as can be seen in **Error! Not a valid bookmark self-reference.**, which presents the longitudinal distribution of the characteristic grain sizes, although minor downstream fining can be noticed.

Figure 3-3 Longitudinal distribution of the grain sizes

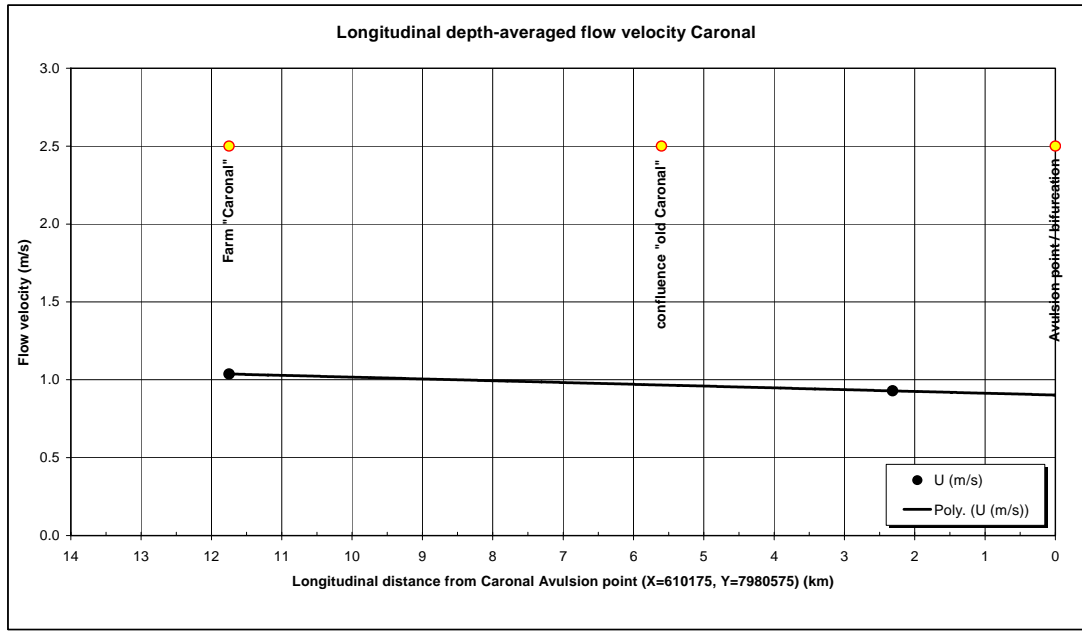
Figure 4-2 Longitudinal distribution of the depth-averaged flow velocity along the thalweg in the New Caronal (March 30<sup>th</sup> to April 4<sup>th</sup>)

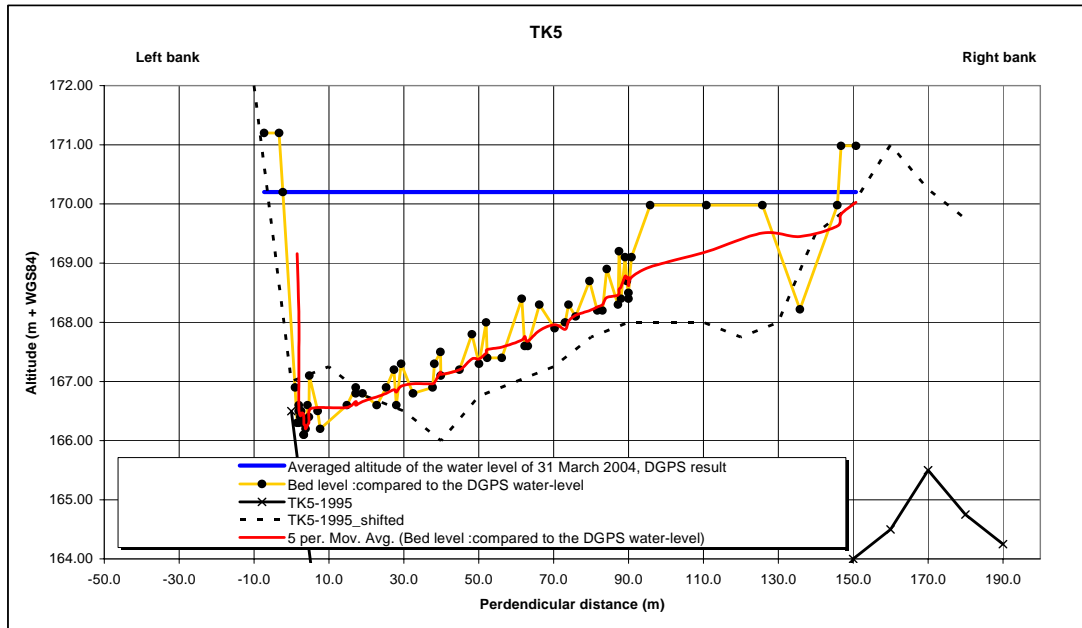
Figure A-3 Measured cross-section TK5 (distance rkm 105.28)

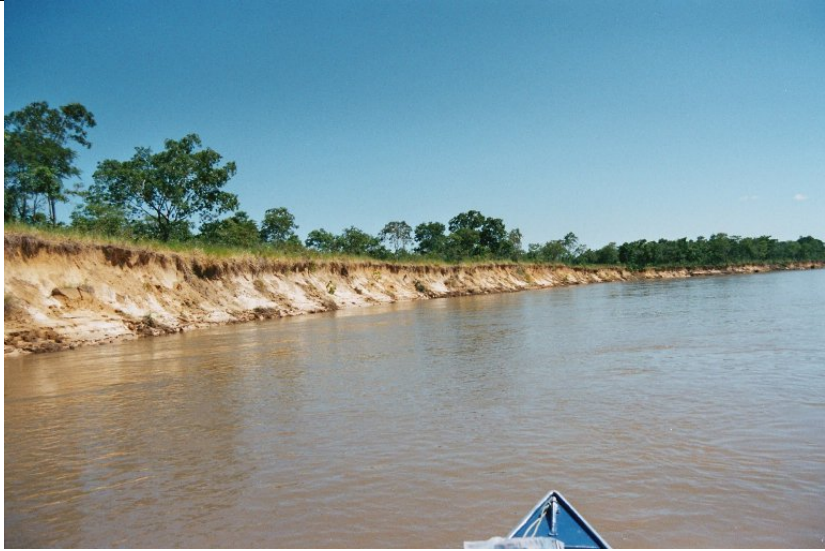
nr. 16	Roll 1
	Description: <i>Coxim, steep river banks / bank erosion</i>	
	X: 0731491	Y: 7957749

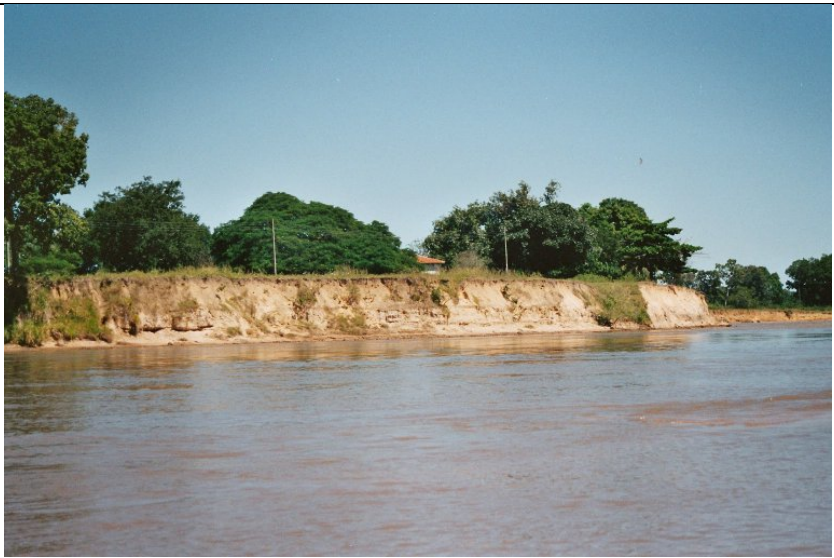
nr. 20	Roll 1
	Description: <i>Major bank erosion, just downstream of the previous picture</i>	
	X:	Y:

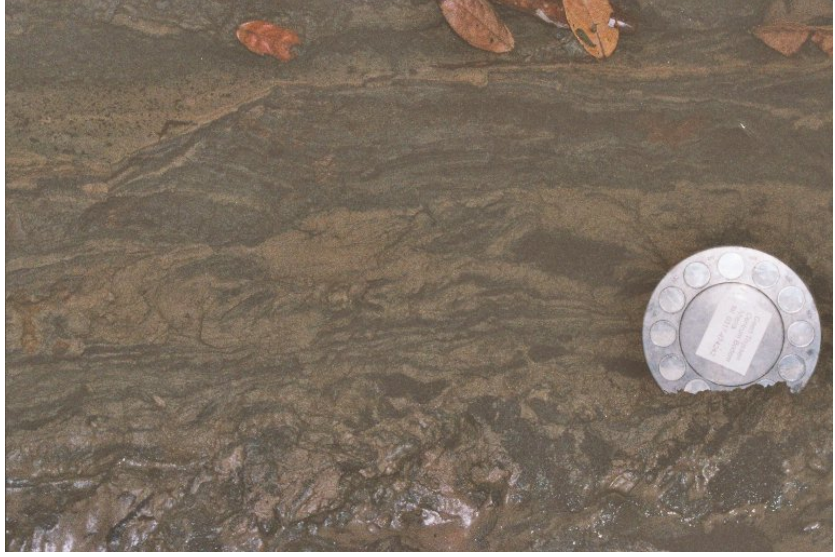
nr. 25	Roll 1	
	Description: <i>Figureial. Bank material (right bank). Opposite site of the previous three pictures</i>		
	X: 0665733	Y: 7983813

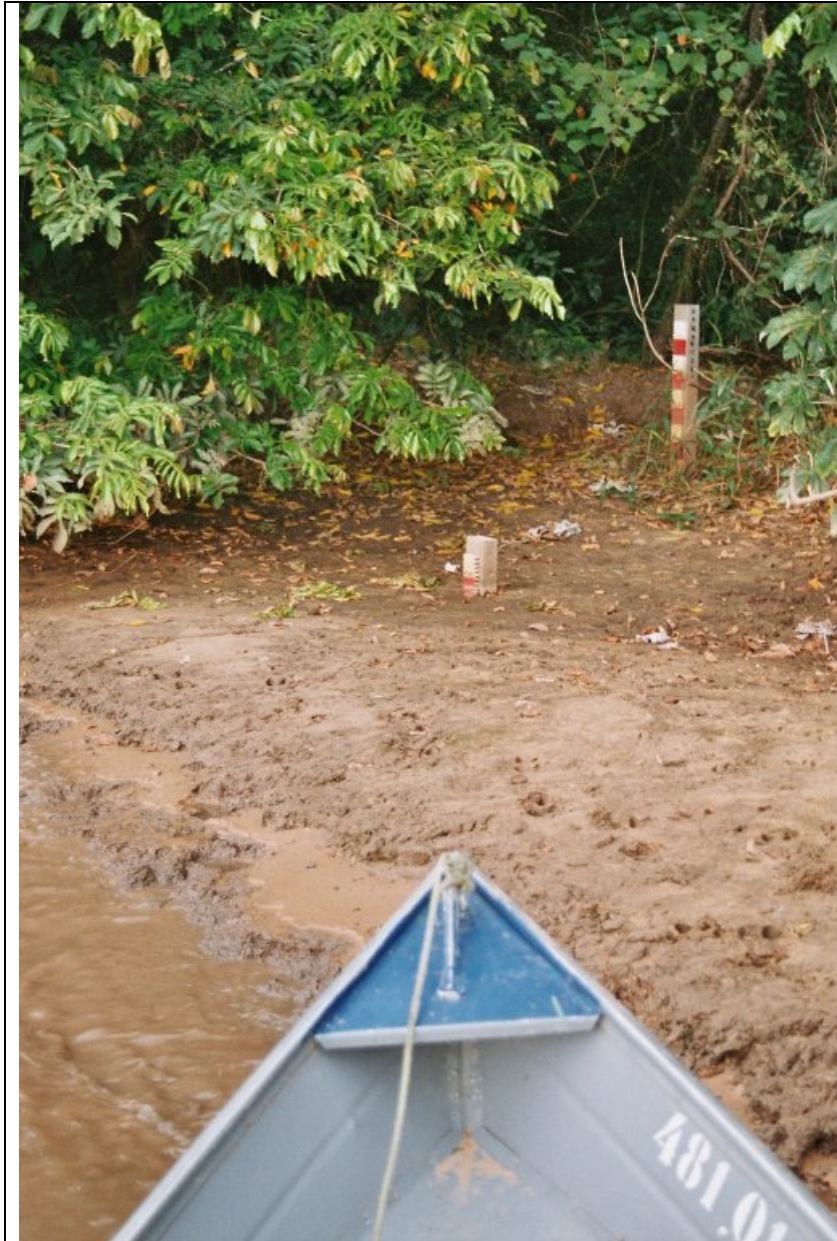
nr. 34	Roll 1
Description: <i>A water level gauge in the Taquari. Water level approx. 0.70 – 0.60 m (reference level not known at this moment)</i>	
X: 632523	Y: 7984070

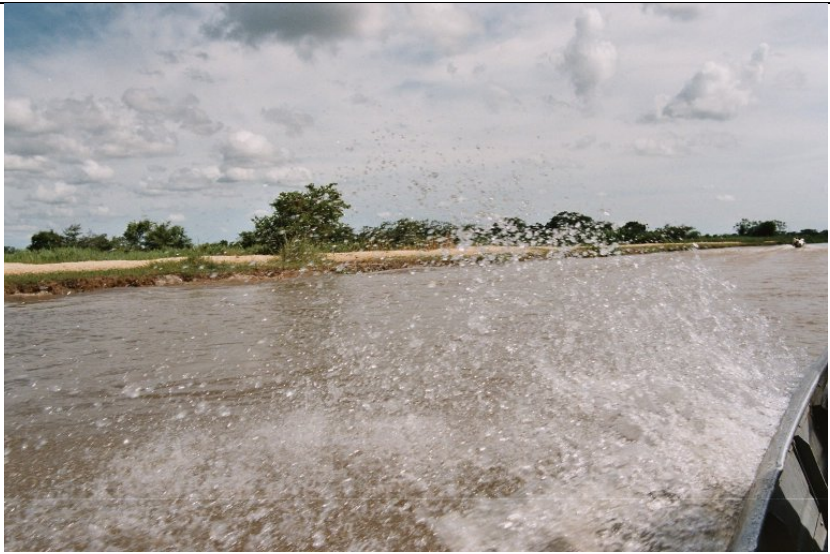
nr. 1	Roll 4
	Description: <i>Dredging works (carried by local farmers). Water level almost equals bottom level here (approx. 20 cm difference). Left bank. picture approx. 500 m after dredging works started. It continues several km's (sediment deposits on left and right banks)</i>	
	X: 0544888	Y: 7962296

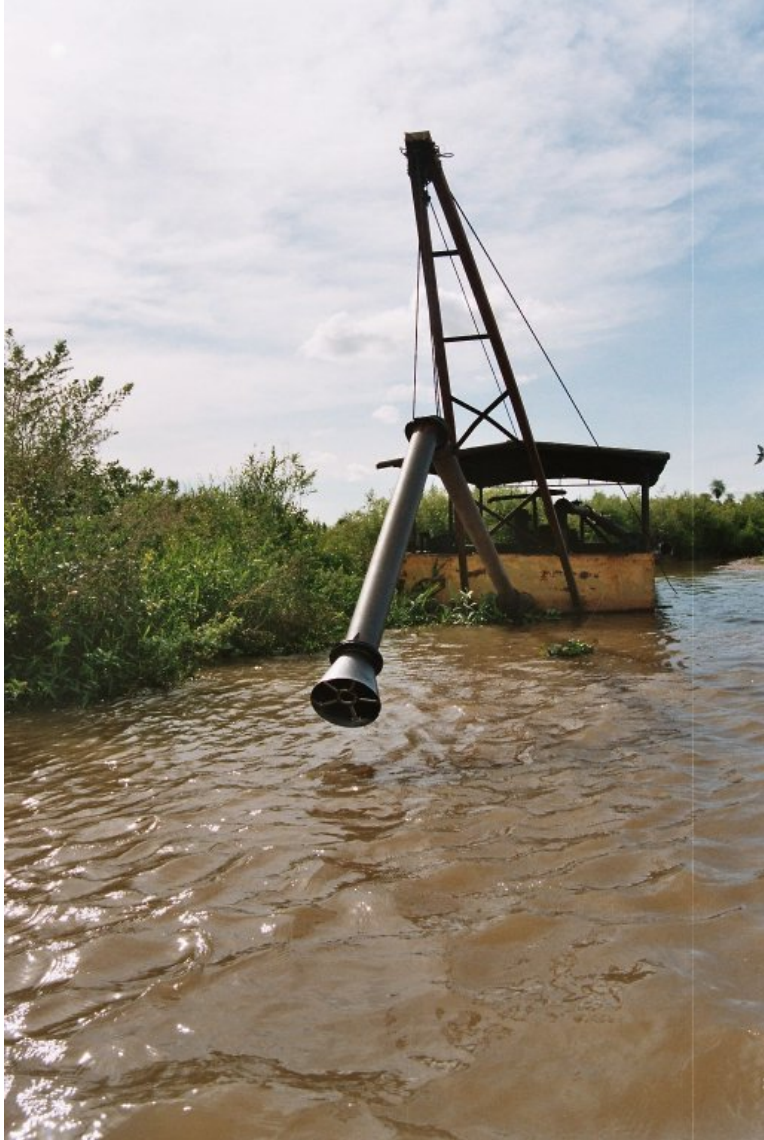
nr. 2	Roll 4
	Description: <i>Dredging barge owned by the local farmer, which is often used</i>	
	X: 0537175	Y: 7959166
